Manhole Inspection Summary

Manhole # S29G__052MH

Insp Date: **1/26/09 12:27 PM**

Location Address: **Fairmount Av**

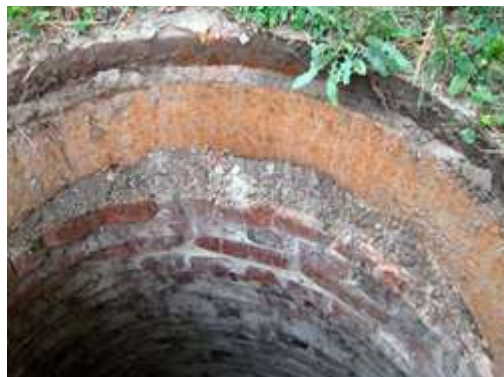
Defect 3

Frame Offset: **2.** (in.)
75

Condition: ☐ Sound ☒ **Cracked** ☒ **Leaks**

Infiltration: ☐ None ☒ **Joint** ☐ Cracks ☒ **Mortar** ☐ Roots ☐ Wall

frame offset; infiltration lid/frame, & at chimney mortar & joint

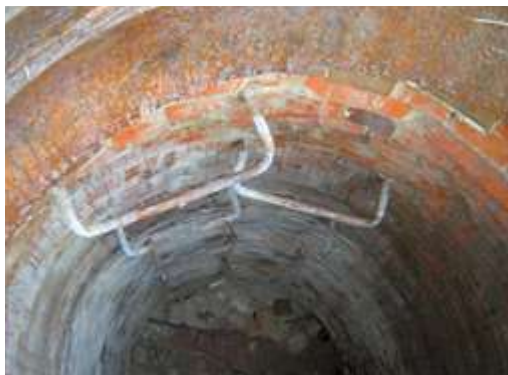
Defect 2

Steps Count: **7** Missing: **0** ☒ **Corroded**

corroded rungs

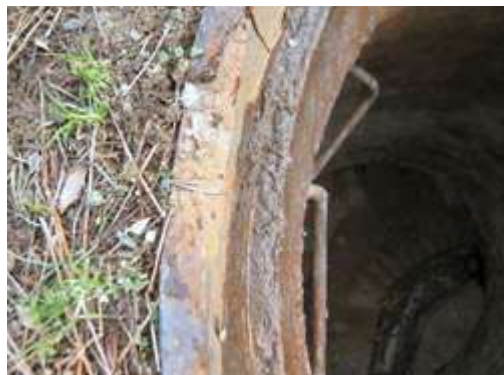
Defect 1

cracked frame

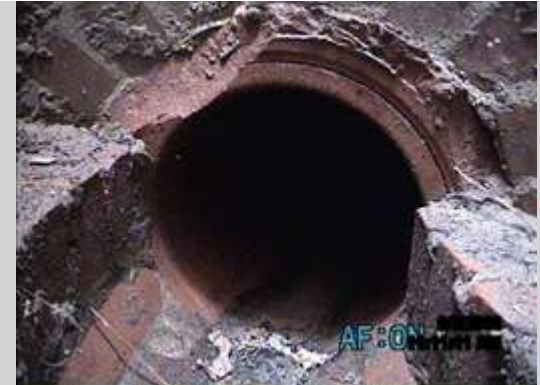
12 O'Clock Outflow

Pipe Height: **10.8** (in.) Rod and Bar (Angled)
Pipe Material: **Clay** ☐ Pipe Lined
Invert Depth: **10.86** (ft.) Flow Characteristics: **Slow**
Deposits: ☒ None ☐ Mud ☐ Sludge ☐ Debris ☐ Grease
Silt Depth: **0** (in.) Deposits Extent:
Infiltration: **None** Pipe Seal Cond: **Broken**
